## Characterization of Single-Crystal Turbine Blades by X-Ray Diffraction Methods

**Keywords:** CMSX-4, superalloys, X-ray topography, turbine blade

**Abstract.** Characterization of structure defects in turbine blades is the basis for determination of the overall crystalline perfections. This work presents the possibilities of identifying casting defects by combining different X-ray diffraction techniques. The investigation was conducted on samples prepared from as-cast turbine blades airfoil and tips. It was found that X-ray topograms revealed dendritic structure and macro strain areas. The defects areas which have appeared on topograms were also investigated by X-ray diffraction mapping technique by EFG diffractometer. Additionally, the X-ray investigation was complemented by macro SEM images obtained by stitching several images of microstructure. The X-ray maps of misorientation angle and X-ray topograms revealed a deviation between the  $\langle 001 \rangle_{\gamma'}$  direction and the blade axis as well as rotation of the primary dendrite arm around this axis.

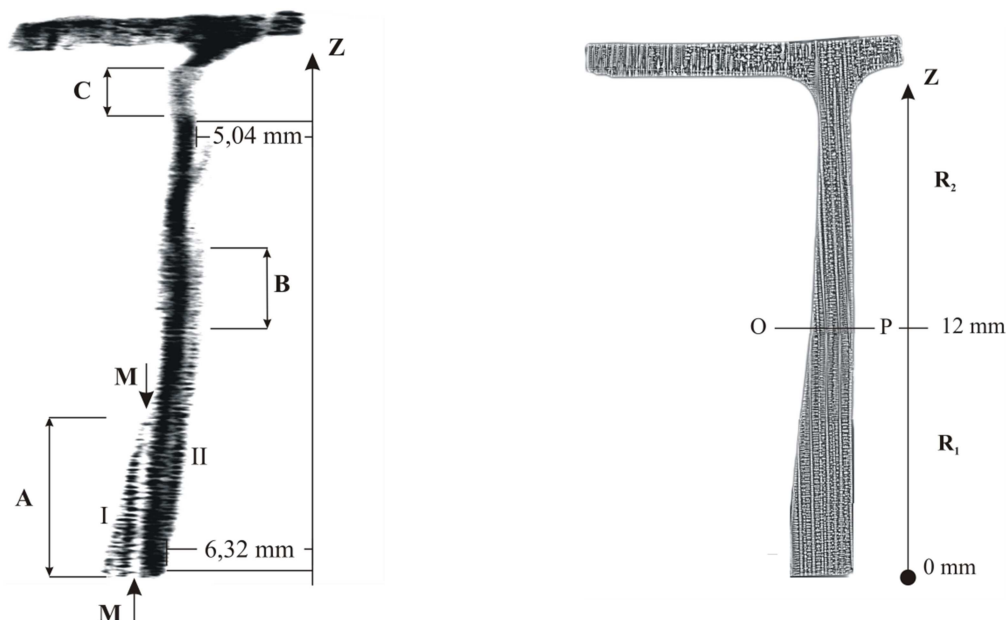
Fig. 2. Typical X-ray topogram (a), and macro SEM images (b) of the airfoil with tip samples.

Figure 2 shows the typical X-ray topogram and macro SEM images obtained from prepared samples used in the investigation. The X-ray topogram images mainly consist of short horizontal lines, with different intensity, arranged parallel to the secondary dendrite arms shown on SEM images (Fig. 3a, b, bands parallel to US). Moreover, topograms revealed a macro subgrain structure with the well-defined low angle boundary marked as MM in Fig. 2a. The misorientation between subgrains I and II was about 0,8 degree. In addition, there are visible changes on the topograms in contrast with some areas which are probably caused by their local macro strain (A,B,C in fig. 2a). On the macro SEM images we were not able to distinguish changes in microstructure directly indicating the presence of a subgrain boundary, which we had shown to be possible in the previous paper [7].

It was shown that dendritic arrangement changes from Z about 12 mm (above OP line Fig. 2b, Fig. 3). This defect was probably caused during the casting procedure. In comparison to areas A and B, primary dendrite arms in area C (Fig. 2a) deviate about few degrees from Z axis ( $\delta$  in Fig. 3c). This deviation appeared as blurring and lower intensity of contrast on topogram in area C. However, contrast blurring of the B area was probably caused by changes in density and arrangement of secondary dendrite arms above the line US (Fig. 3b).

The X-ray diffraction mapping conducted on the EFG diffractometer was obtained only from region R1, the diffractometer was not able to collect data from X-ray reflexes in R2. The results revealed the same subgrain structure on both maps alpha and beta angle. The misorientation between subgrain ( $\alpha$ ) was about 0,8 degree which was confirmed by both X-ray topography and X-ray diffraction mapping methods. The beta angle shows continuous decreasing of around 22 degree within subgrain II. It was caused by the rotation of dendrites along the Z axis. The bending of the X-ray topography images could also be the reason of that rotation. The topogram shows bending (Fig. 2a in respect to the Z axis) which was not caused by the real shape of the sample (Fig. 2b).

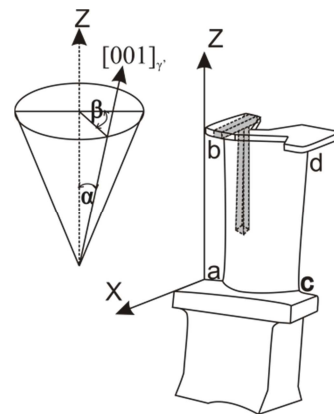
Fig. 1. Sample geometry with marked samples location (grey region). ab – leading edge; cd – trailing edge.

The blade geometry with marked samples location for investigation is shown in Fig. 1. The maximum deviation from  $\langle 001 \rangle_{\gamma'}$  direction ( $\alpha$  angle, Fig. 1) determined by Laue diffraction was around a few degrees. All samples were prepared by electro spark cutting parallel to the XZ plane near the leading edge of blade airfoil. Surface of the samples were then prepared using the standard metallographic procedure. The X-ray topography results were obtained by Panalitical microfocus X-ray source on AGFA structurix D7 FW X-ray film. The topography geometry was set-up for back-reflection. The full description can be found in [8]. All topograms were obtained with the use of Cu  $K_{\alpha}$  200 reflection of the  $\gamma'$  phase. To complement the X-ray topography investigation, the X-ray mapping of alpha and beta angle (Fig. 1) was performed on the EFG diffractometer. The deviation angle between  $\langle 001 \rangle_{\gamma'}$  direction and the blade axis Z ( $\alpha$ ) and rotation of  $\gamma'$  phase about this axis ( $\beta$ ) were studied. Additionally, the SEM investigation was performed on JOEL JMS 6480.

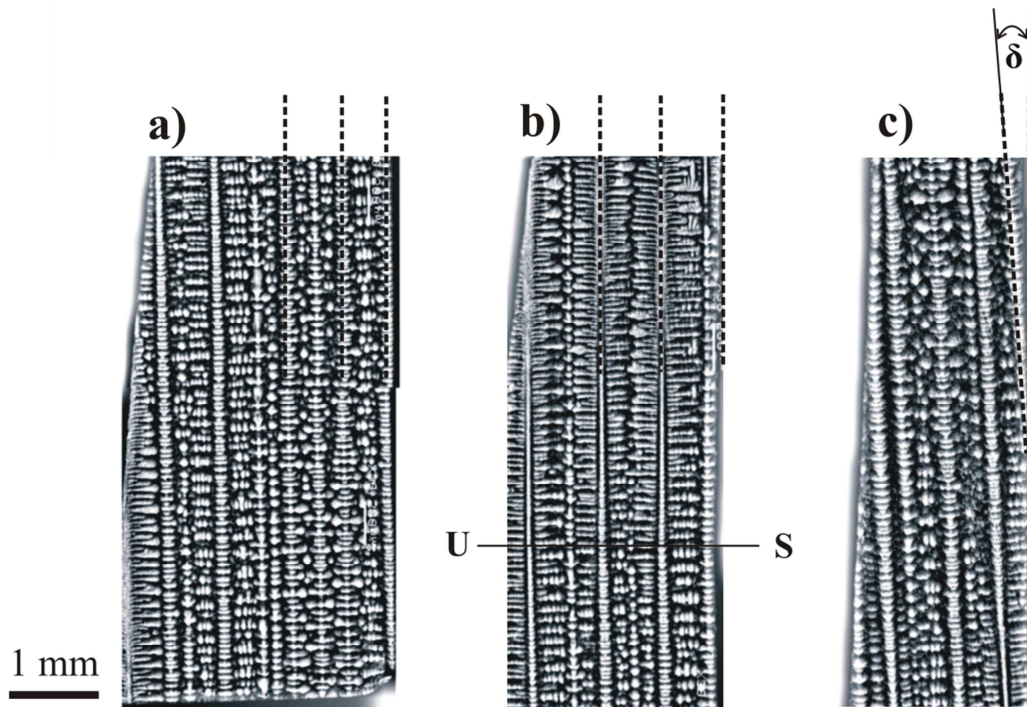
Fig. 3. SEM images of A(a), B(b) and C(c) areas marked in the Fig. 2
